13 April 2011

Ref: 301015-02233-MA-RP-0001 - 110411  
Wyndham Boat Ramp Floating Jetty.Doc

## **WYNDHAM BOAT RAMP FLOATING JETTY OPTIONS FOR MAINTENANCE AND REPLACEMENT**

WorleyParsons was engaged by Shire of Wyndham East Kimberley (SWEK) to provide advice in relation to a recent pile failure at the Wyndham Boat Ramp Floating Jetty.

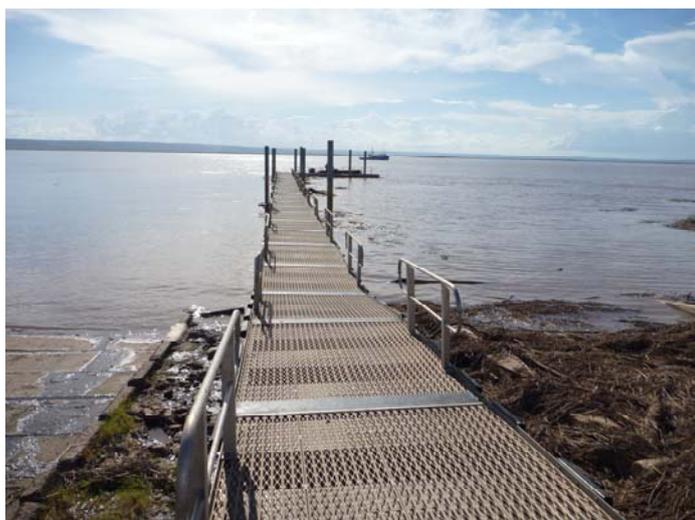
The Wyndham Boat Ramp Floating Jetty (refer Photo 1) was built in 1998. A visual inspection of the floating facility was undertaken on 17 March 2011.

**Photo 1: General view of structure**

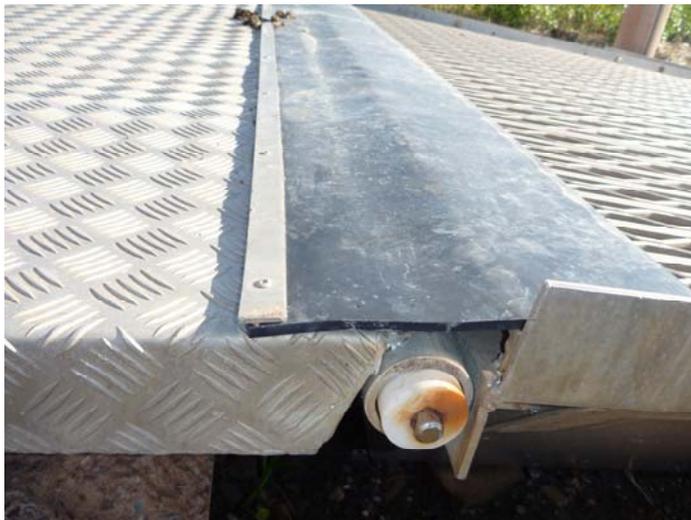
The floatation components on each pontoon unit consists of 3 aluminium box sections, and each pontoon unit is connected to one another via a hinge type connection (refer Photo 2). The hinge connection typically has a rubber cover strip however several of the cover strips were observed to be missing. The trafficable surface of the pontoon system is an extruded aluminium mesh.

**Photo 2: Hinge joining pontoon units with rubber cover strip**

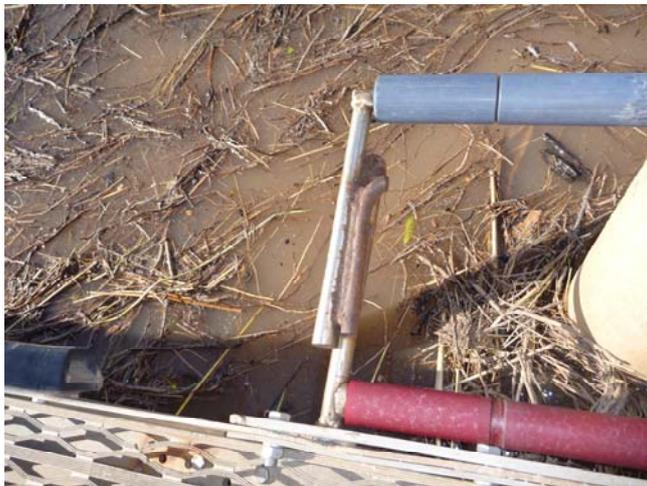
The pontoon system is connected to piles via pontoon guides which are fabricated out of small diameter aluminium bar and plate. Most of the pile guides are bent and flimsy (refer Photo 3), indicating over stressing of the structural components, and not fit for purpose.

**Photo 3: Pile Guide with repair in place**

1. Continue to repair the pile guides when failures becomes obvious, on a reactive basis.
2. Replace the pile guides with larger, fit for purpose structural members. This option would be particularly appropriate if the existing piles were to be upgraded.

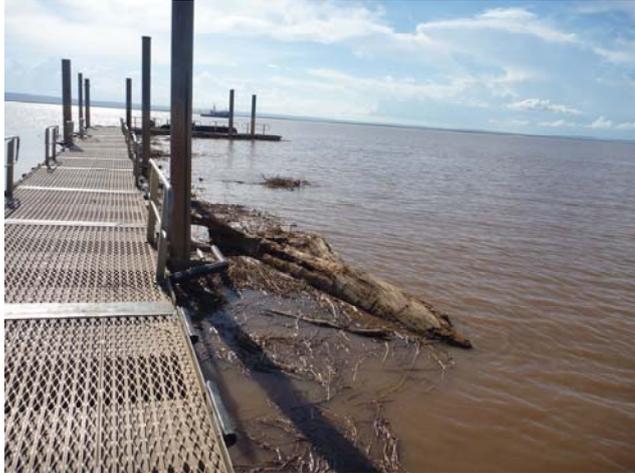
It is understood that several piles were replaced following a large debris event approximately 7 years ago (refer Photo 4 showing a small amount of debris caught on structure).

**Photo 4: Debris caught on structure**

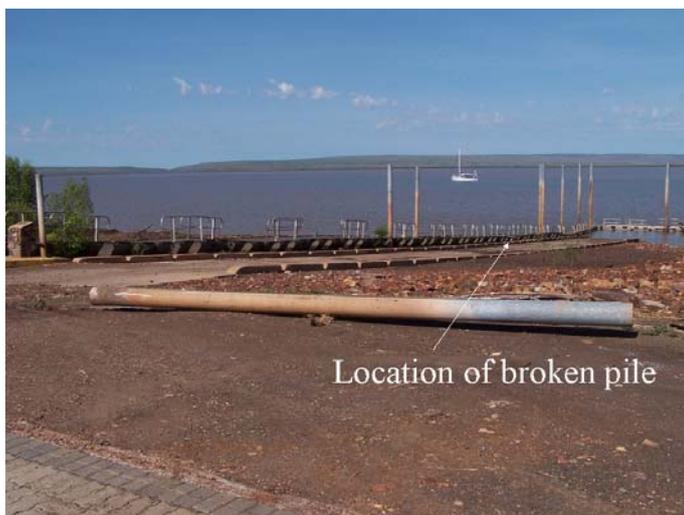
On 15 December 2010, a pile failed due to corrosion through the welded splice connection (refer Photos 5 and 6), and corrosion through holes in the steel piles (refer Photo 7 for example of corrosion through holes in piles).

**Photo 5: Broken pile (15 December 2010 failure)**

Given the number of pile failures over the past 7 years due to debris loading and corrosion, it is highly likely that further, more frequent failures will continue to occur, particularly given the poor welding observed in the 15 December 2010 pile failure and the presence of holes in the steel piles allowing corrosion to accelerate.

2. Replace the existing piles with larger, thicker walls steel piles (for example a 457mm diameter by 12.7mm wall thickness Circular Hollow Section (CHS) pile – section size is an estimate only and would need to be confirmed by calculations), with welded caps at the top and an epoxy paint or high density polyethylene (HDPE) sleeve corrosion protection. This option would be more expensive than Option 1 in the short term but would likely lead to a lesser overall life cycle cost. It is noted that Maritime Constructions currently has a piling barge mobilised at Anthon Landing and as such there is an opportunity to upgrade the piling on the facility for a reduced cost as mobilisation / demobilisation costs are covered by the Wyndham Community Jetty project.

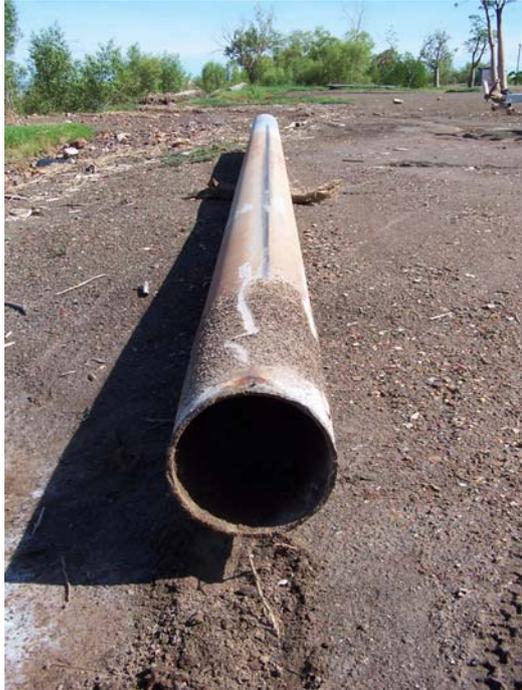
**Photo 7: Broken pile (15 December 2010 failure)**

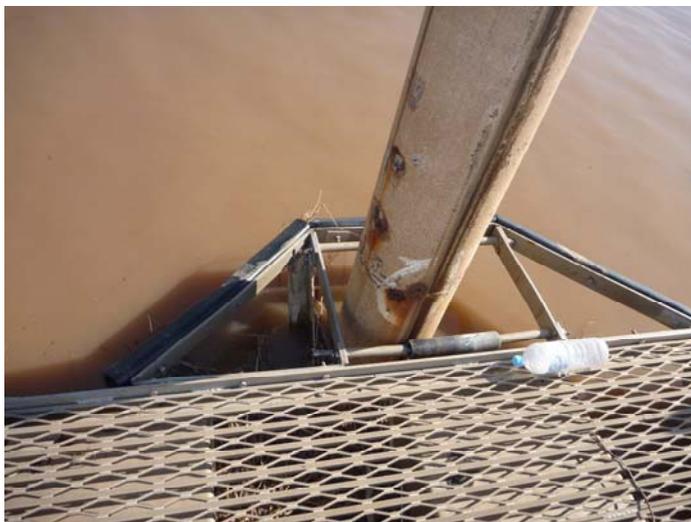
It is understood from SWEK that the original wall thickness of the galvanised steel piles was 6mm. Six of the piles are missing a top cap which decreases durability by allowing the piles to corrode from the inside and outside, thus doubling rate of corrosion. Typical corrosion rates for steel in a salt water splash zone are approximately 0.1mm per annum. For corrosion on the inside and outside, this could equate to a loss of 2.4mm of wall thickness since construction.

**Photo 7: Corrosion on steel pile**
