VISUAL INSPECTION OF PARKING KDHS, MANGALOO STREET, KUNUNURRA

Friday 26 July 2019

VISUAL INSPECTION OF PARKING KDHS, MIDDAY

VISUAL INSPECTION OF PARKING KDHS

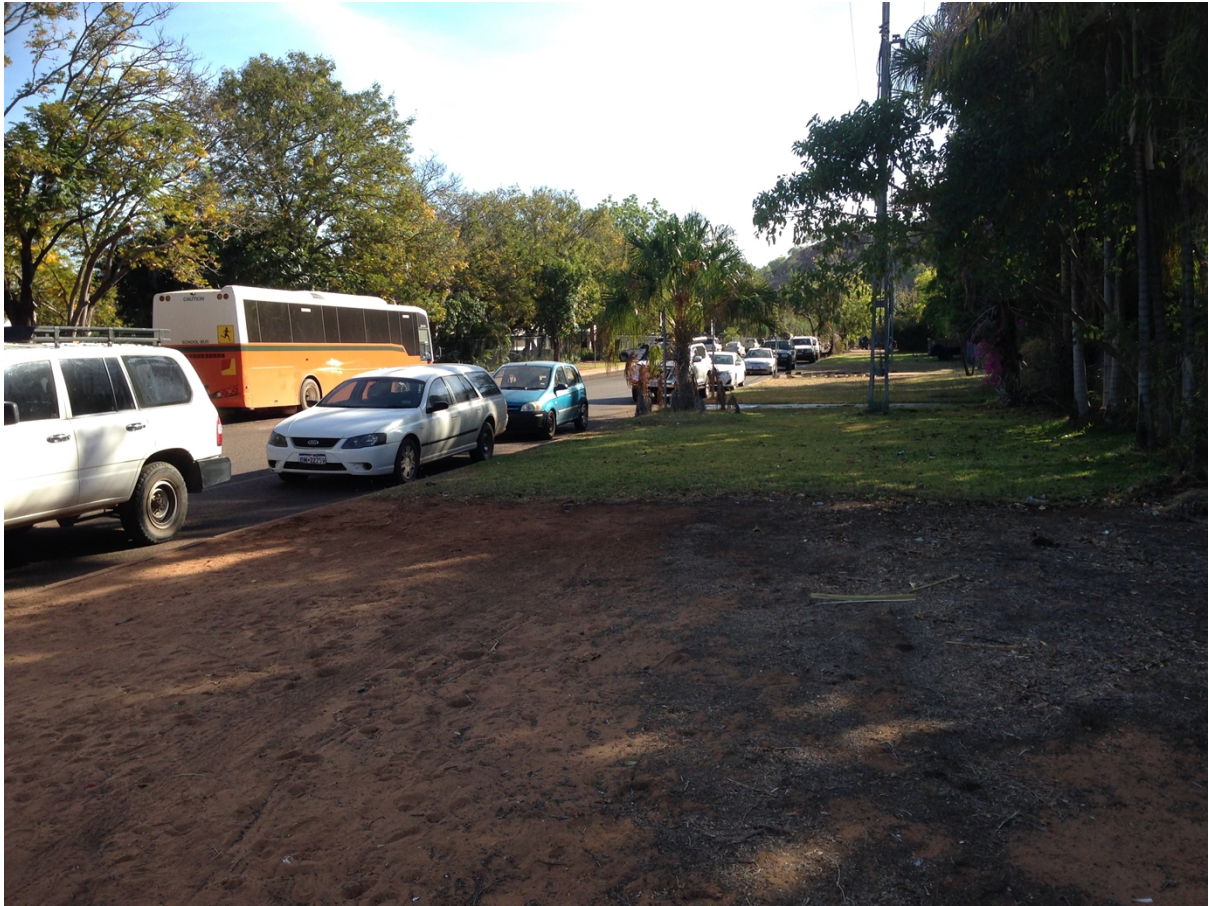
Image of parking from speed plateau, facing North.

The Eastern side of the road not clearly designated in any form of parking, which is in the majority utilised by unattended parked vehicles. During the observance period, 2 bays were available, with a third becoming available at 8:05am.

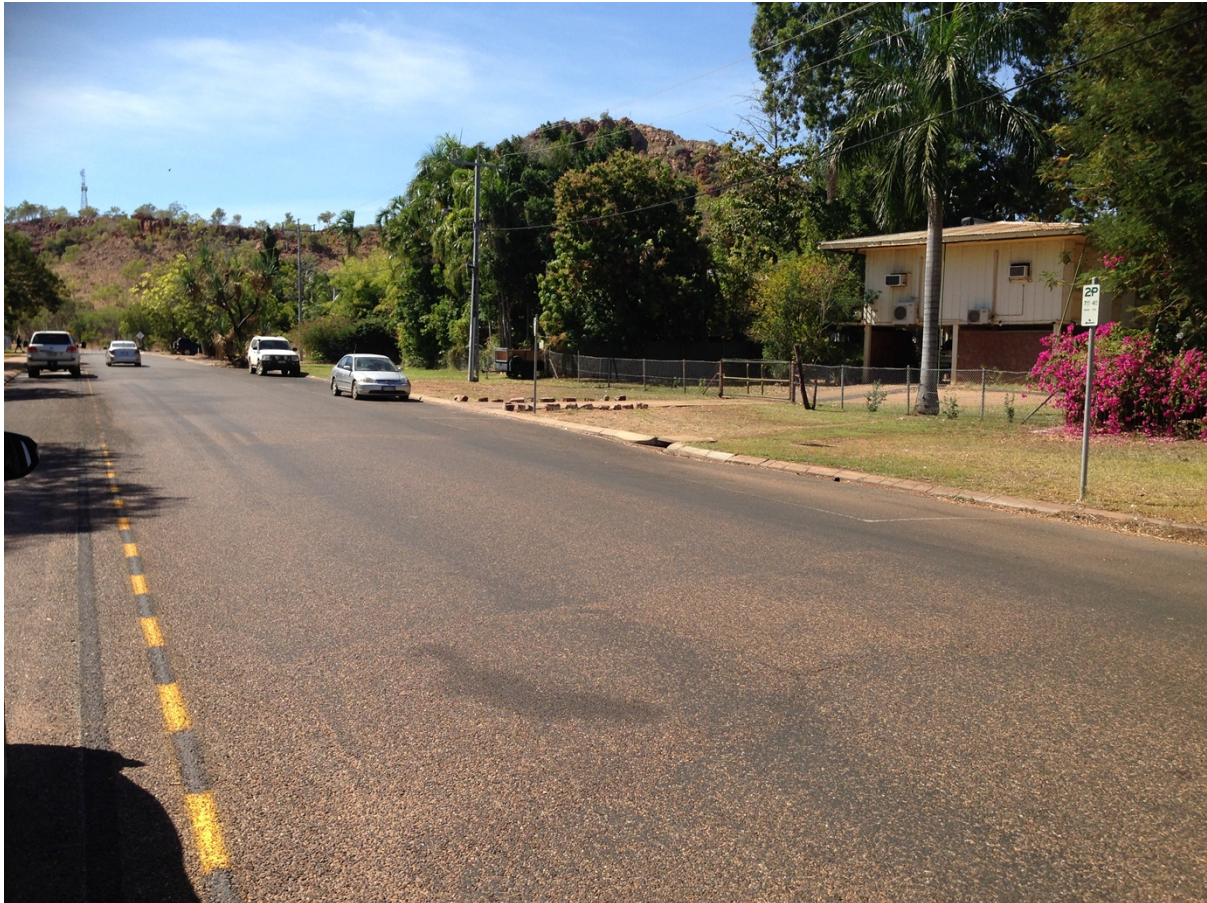
Observation of the site was undertaken at midday, and it was noted that there were few vehicles parked in the bus bay, and designated parking area.

Image from speed plateau, Western side of road, facing North.

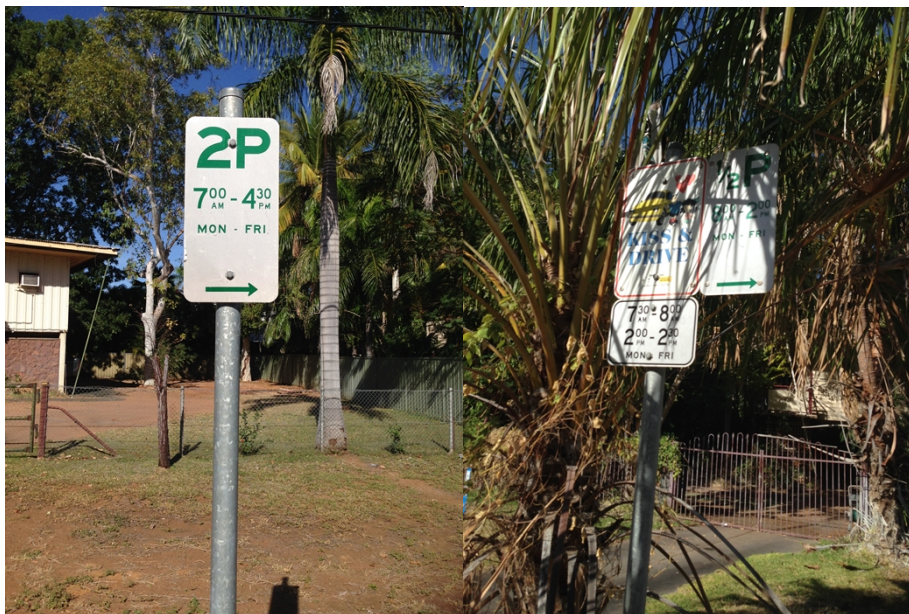
Inspection of parking signs along the Eastern side of the road, demonstrated a mixed signage that in the majority supported 2 hour parking from 7am to 4:30pm Monday to Friday, which no limitation on parking outside of this period.

The next sign to the South, indicated differing parking times, and nominated a 'Kiss and Drive' option.

Convoluted signage in Eastern side parking.

Consideration to more appropriate parking on the Eastern side of Mangaloo Street should be considered.
